SUBJ: EPA Asbestos Removal at 229 Eden Street

REMOVAL ACTION STATUS REPORT DAVIDSON ASBESTOS

Property Address: 229 Eden Street, Davidson, Mecklenburg County, North Carolina

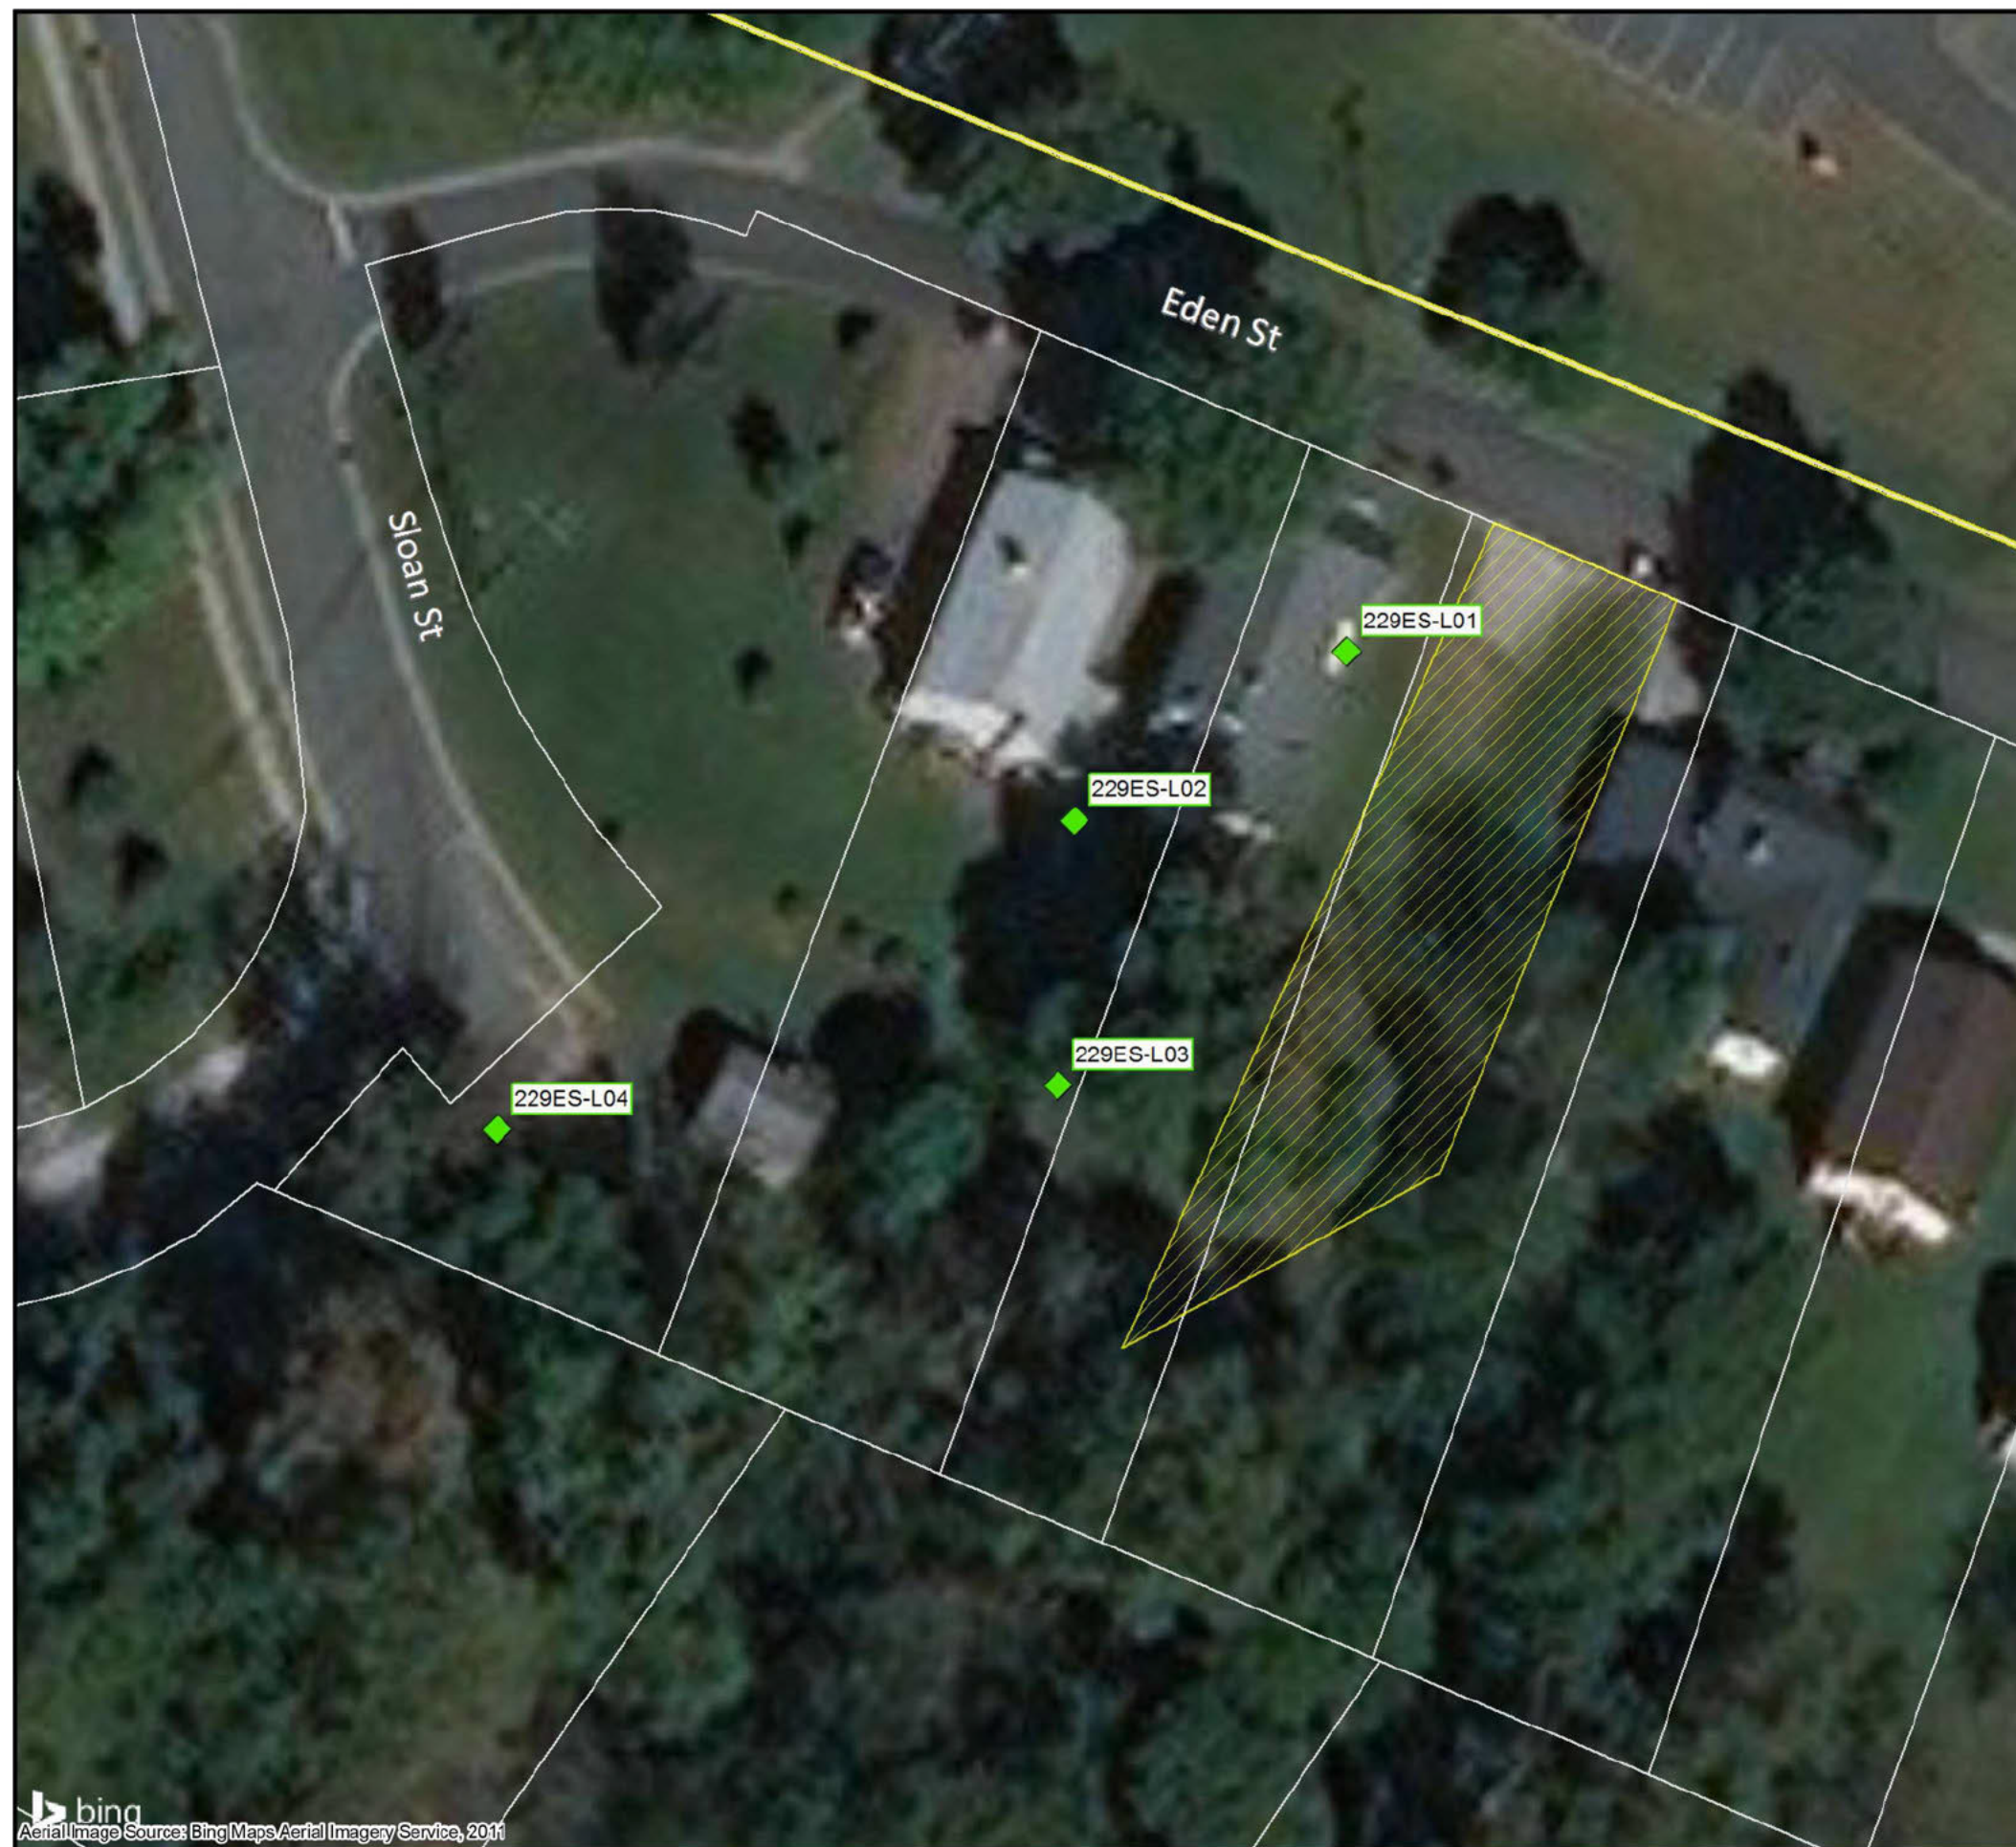
FIGURE 1

Removal Areas and
Air Sampling Locations

Description of Removal Action: The soil was excavated to an approximate maximum depth in the following areas: lawn to 36 inches and tree line areas to 3 inches (see Appendix 1). Visual inspections of the areas excavated for asbestos-containing materials (ACM) were conducted by a State of North Carolina-accredited asbestos inspector and air monitor. Additional removal was conducted in those areas where ACM were still visibly present, except along the base of the driveway and the street to prevent destabilization of their foundations. Once ACM was no longer visibly present throughout the main portion of the excavated area, restoration was allowed to commence. The visible, remaining ACM was photographed and documented in the site logbook before restoration began.

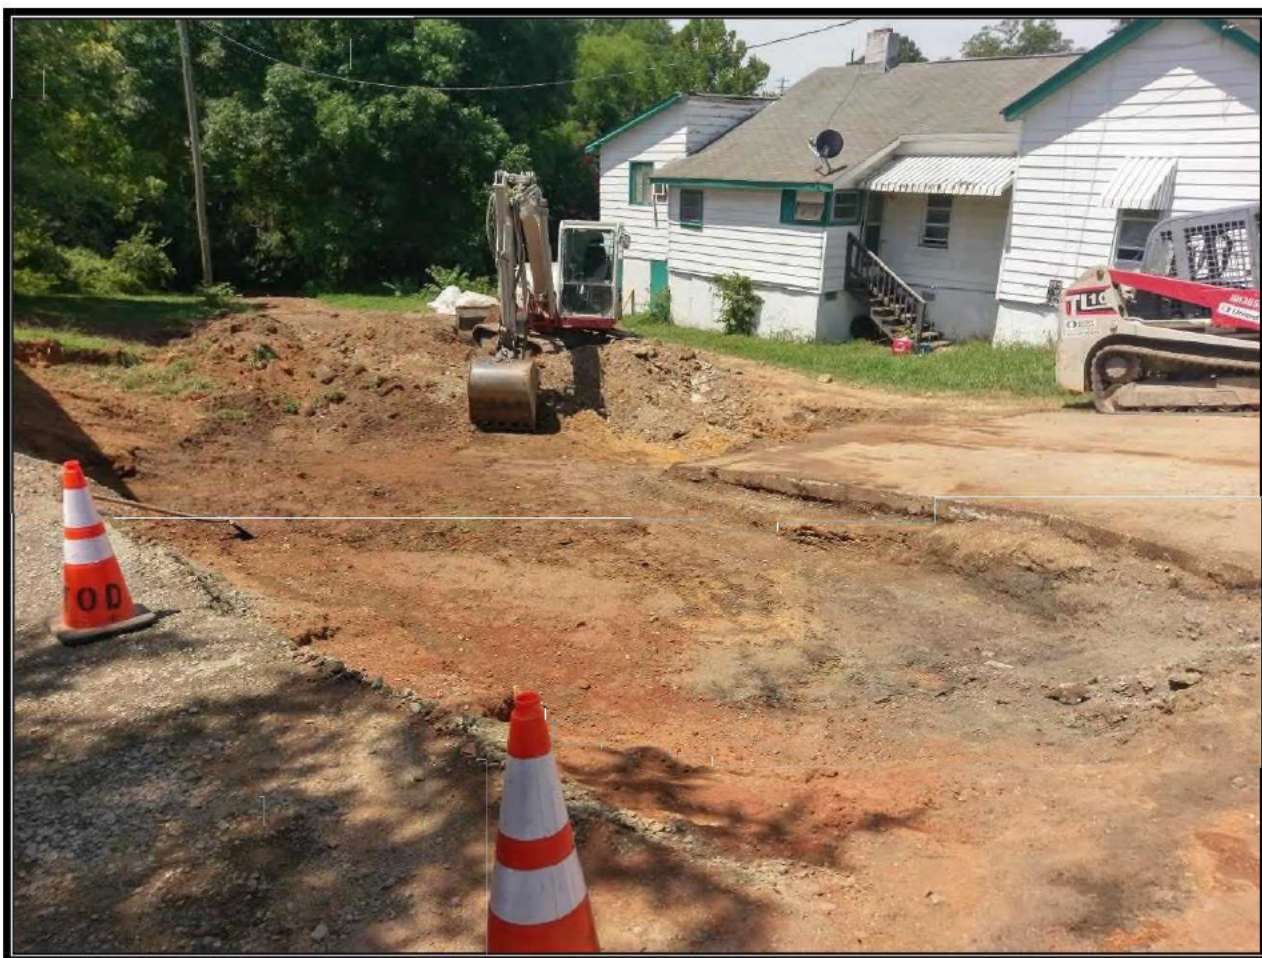
OFFICIAL PHOTOGRAPH NO. 1
U.S. ENVIRONMENTAL PROTECTION AGENCY

Subject: The Emergency and Rapid Response Services (ERRS) contractor, Environmental Restoration, LLC (ER), used an excavator and hand tools to remove asbestos-containing materials (ACM) and asbestos-contaminated soil from the property located at 229 Eden Street. ER used hoses to wet the asbestos-contaminated soil during removal activities.

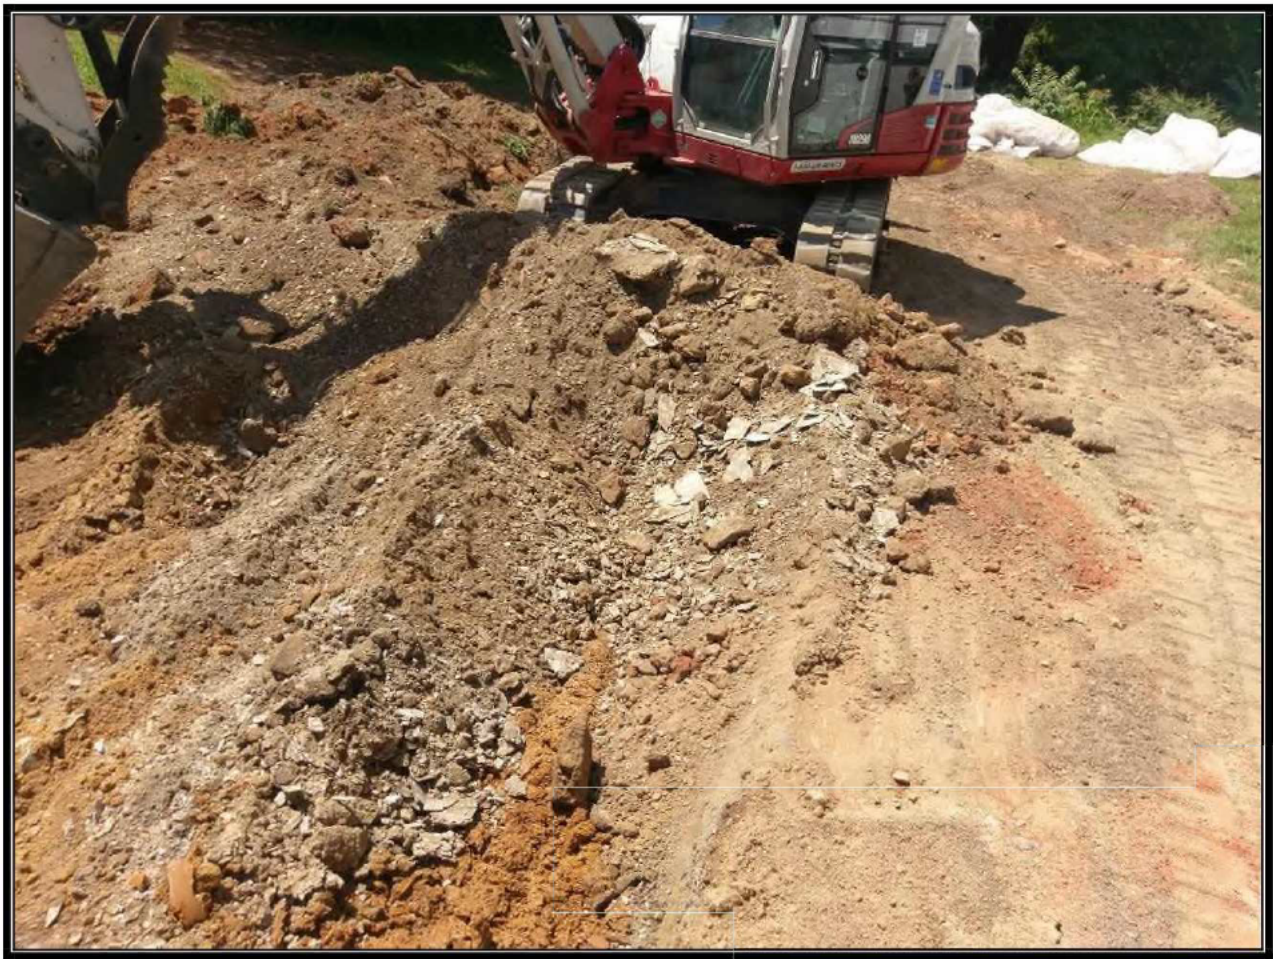
OFFICIAL PHOTOGRAPH NO. 2
U.S. ENVIRONMENTAL PROTECTION AGENCY

TDD Number:	TT-01-071	Location:	Davidson Asbestos
Orientation:	Not applicable	Date:	July 24, 2017
Photographer:	Paul Prys, Tetra Tech, Inc. (Tetra Tech)	Witness:	None
Subject:	Heavy concentrations of ACM were visible at this property during removal activities. ER used hoses to wet the ACM and asbestos-contaminated soil during removal activities.

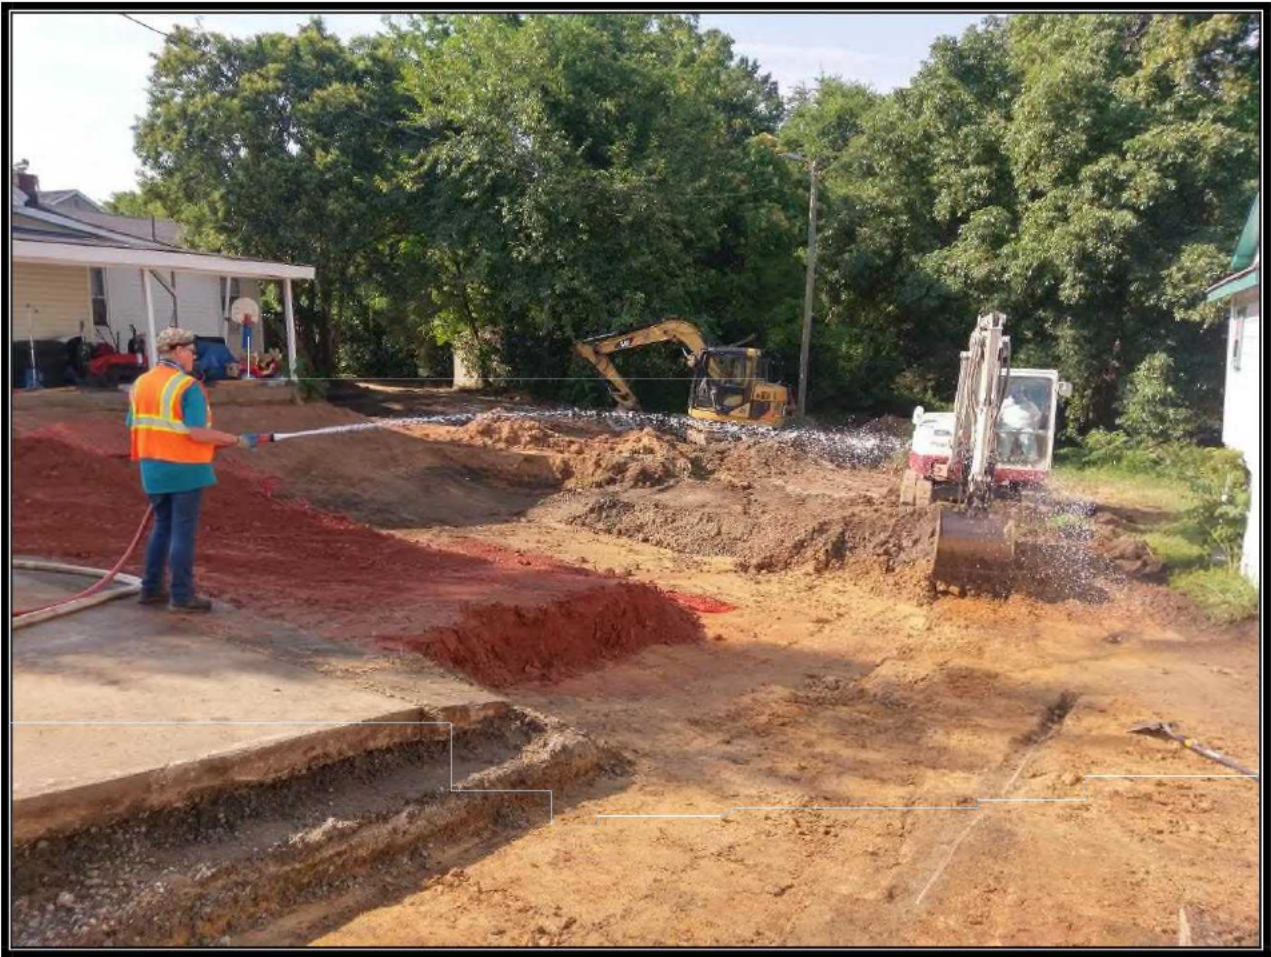
OFFICIAL PHOTOGRAPH NO. 3
U.S. ENVIRONMENTAL PROTECTION AGENCY

TDD Number:	TT-01-071	Location:	Davidson Asbestos
Orientation:	Southeast	Date:	July 25, 2017
Photographer:	Paul Prys, Tetra Tech, Inc. (Tetra Tech)	Witness:	None
Subject:	ER used hoses to wet the ACM and asbestos-contaminated soil during removal activities.

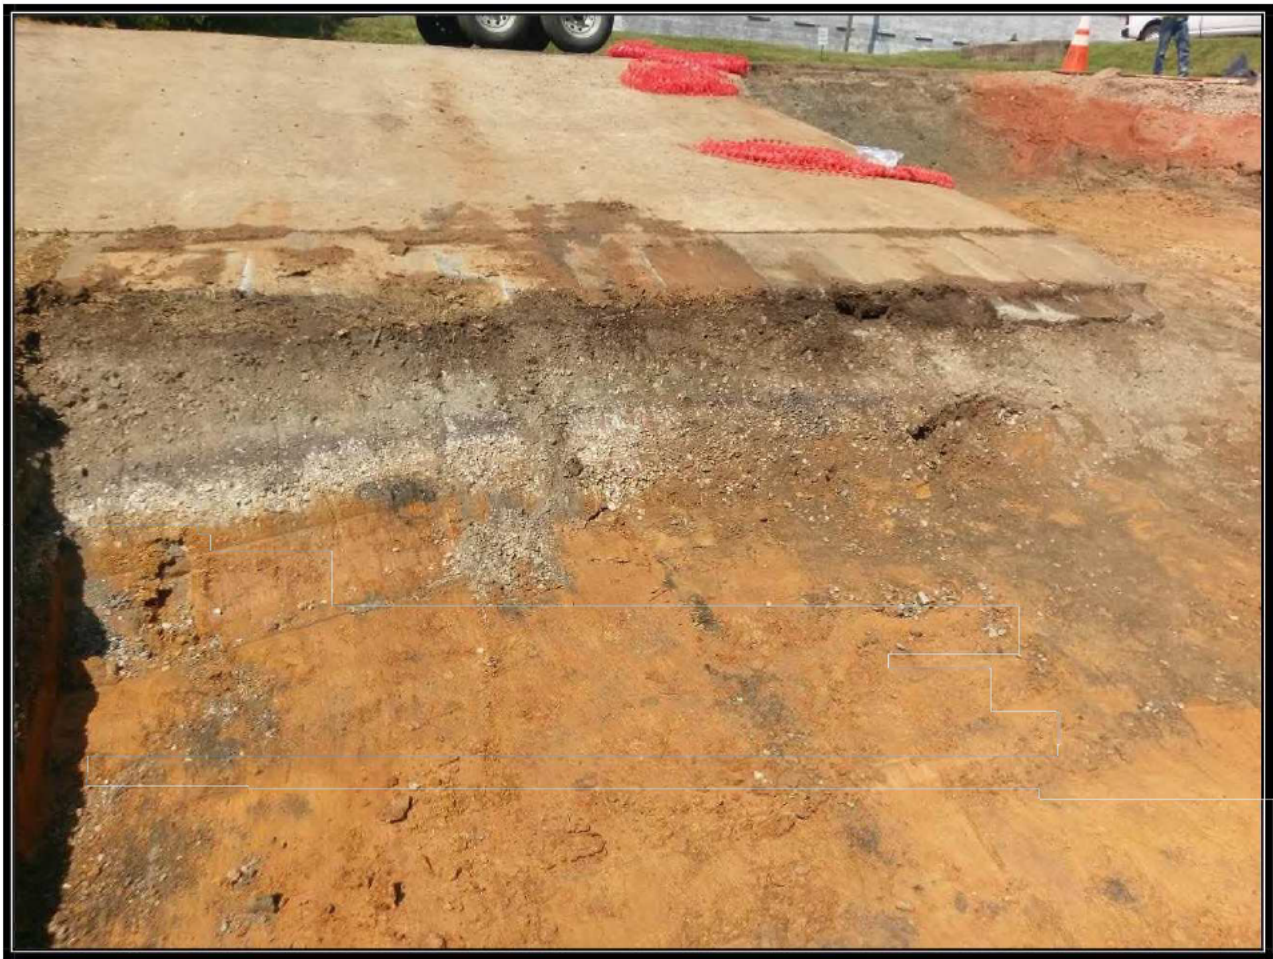
OFFICIAL PHOTOGRAPH NO. 4
U.S. ENVIRONMENTAL PROTECTION AGENCY

Subject: A Tetra Tech Superfund Technical Assessment and Response Team (START), State of North Carolina-accredited asbestos inspector and air monitor, visually inspected the excavated areas for the presence of visible ACM. ER removed additional soil in those areas where ACM were still visibly present, except along the base of the driveway and the street to prevent destabilization of their foundations.

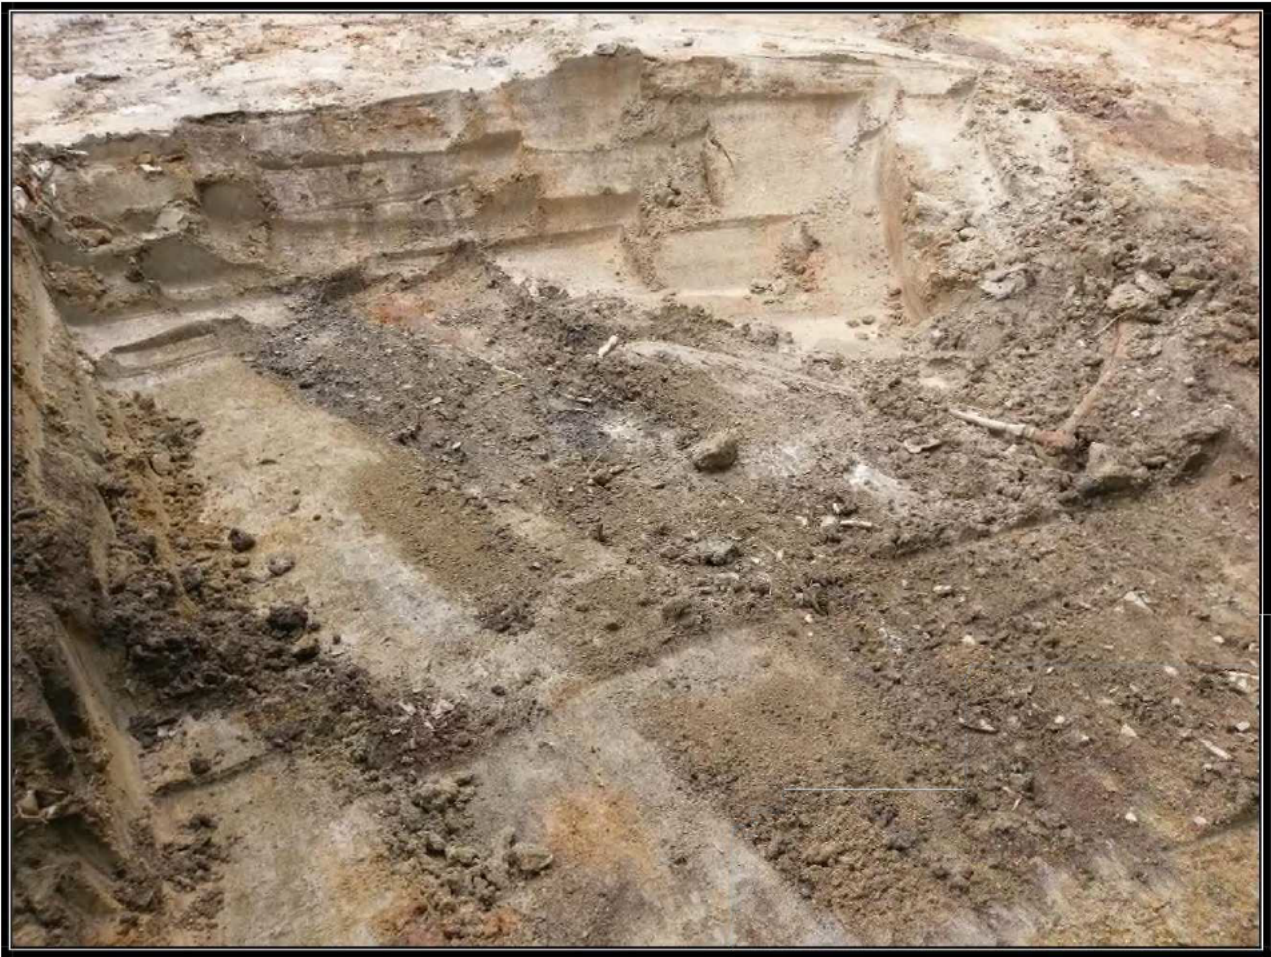
OFFICIAL PHOTOGRAPH NO. 5
U.S. ENVIRONMENTAL PROTECTION AGENCY

Subject: A Tetra Tech START, State of North Carolina-accredited asbestos inspector and air monitor, visually inspected the excavated areas for the presence of visible ACM. ER removed additional soil to a maximum depth of 36 inches from those areas where ACM were still visibly present.

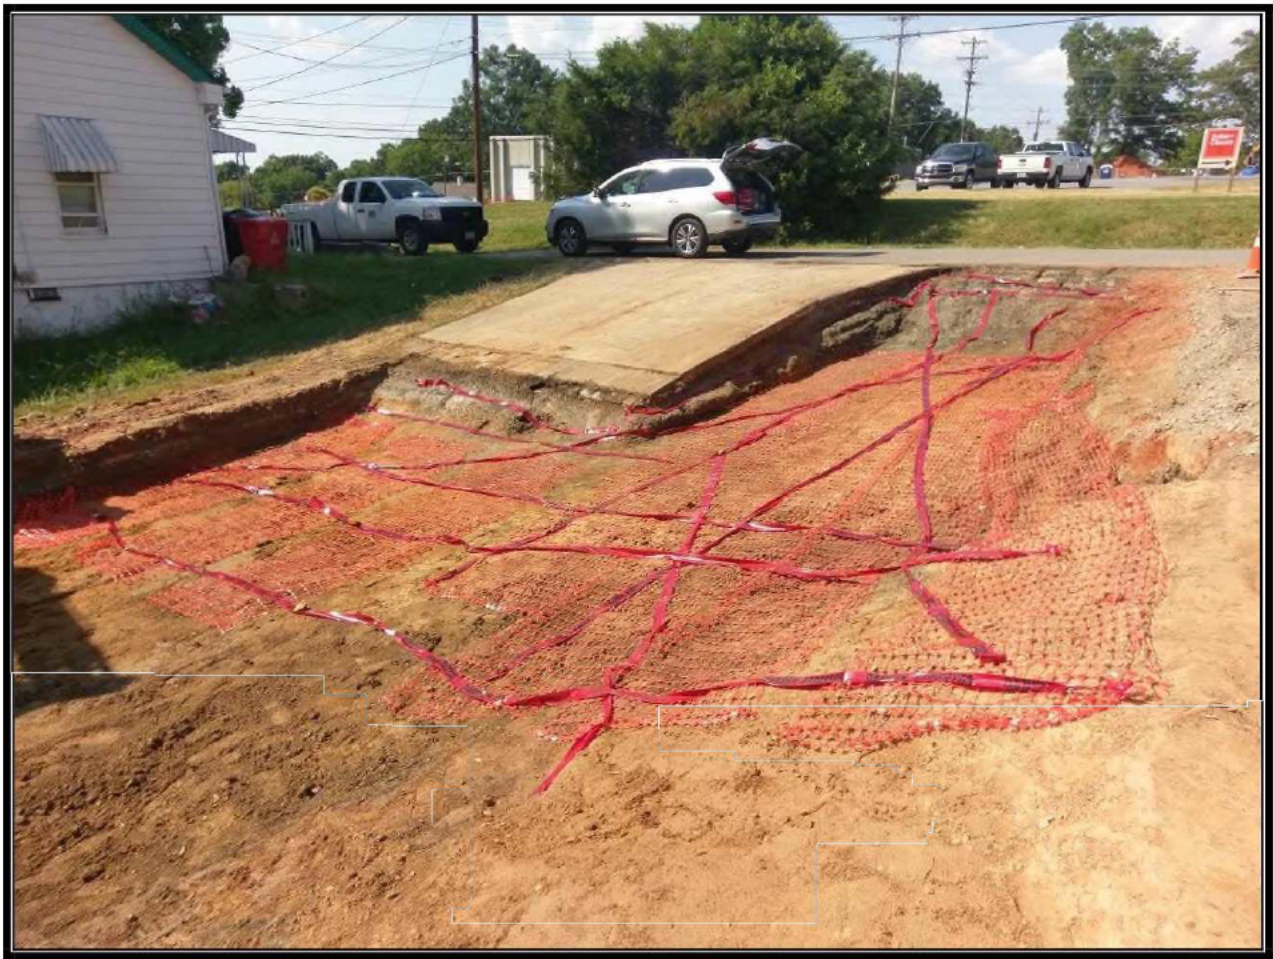
OFFICIAL PHOTOGRAPH NO. 6
U.S. ENVIRONMENTAL PROTECTION AGENCY

Subject: ER installed snow fencing and red "Danger Asbestos" tape along the subsurface of the excavated area to identify the depth of the excavation and the presence of ACM after the visual inspection conducted by Tetra Tech START, State of North Carolina-accredited asbestos inspector and air monitor, detected the presence of visible ACM..

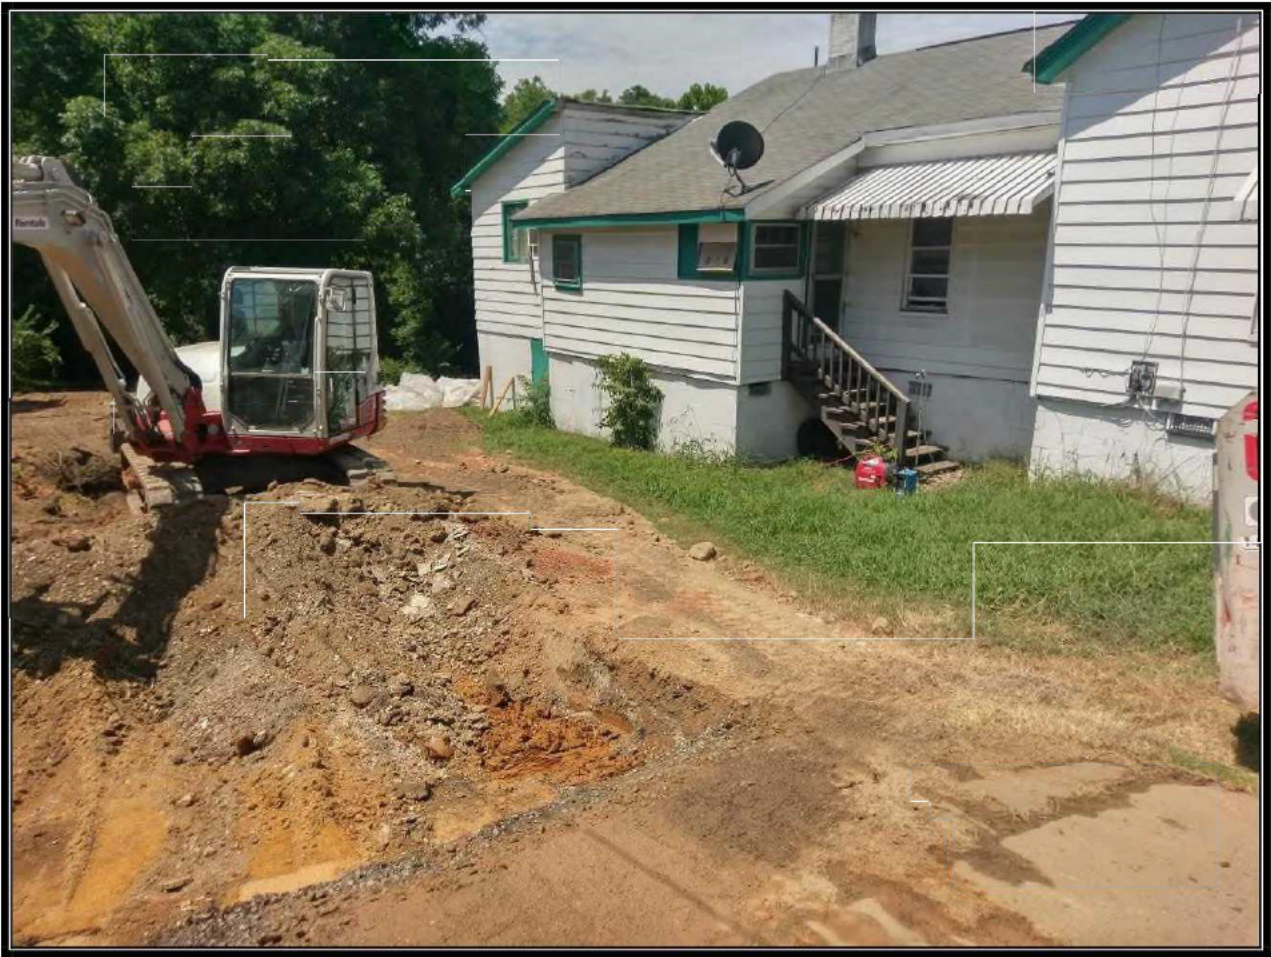
OFFICIAL PHOTOGRAPH NO. 7
U.S. ENVIRONMENTAL PROTECTION AGENCY

Subject: Perimeter air sampling was conducted by a Tetra Tech START, State of North Carolina-accredited air monitor, to evaluate the effectiveness of engineering and safety controls in preventing the off-site migration of asbestos fibers during removal activities.

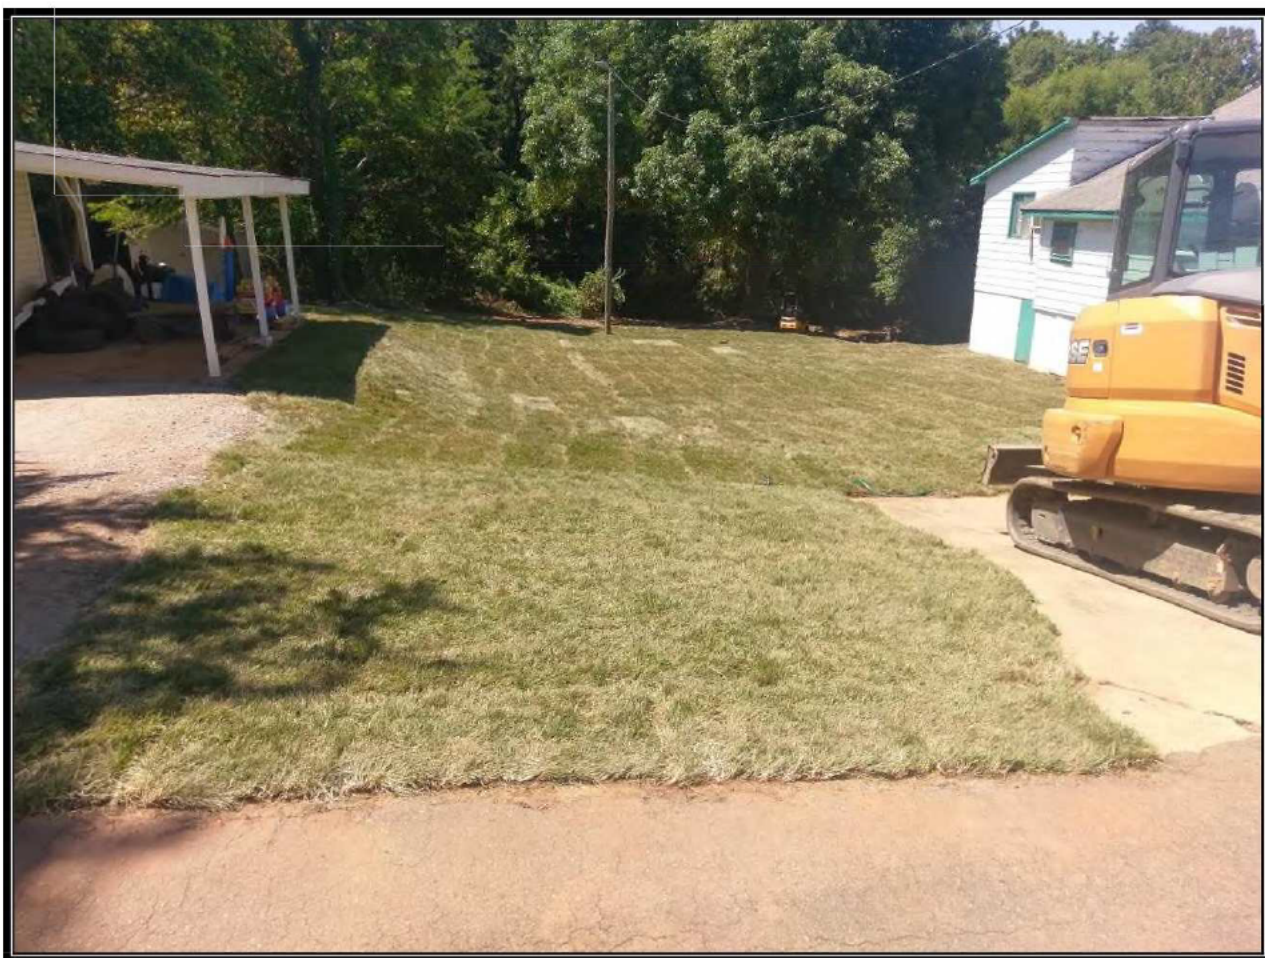
OFFICIAL PHOTOGRAPH NO. 8
U.S. ENVIRONMENTAL PROTECTION AGENCY

Subject: ER installed sod in the excavated areas after backfill and topsoil were in place.

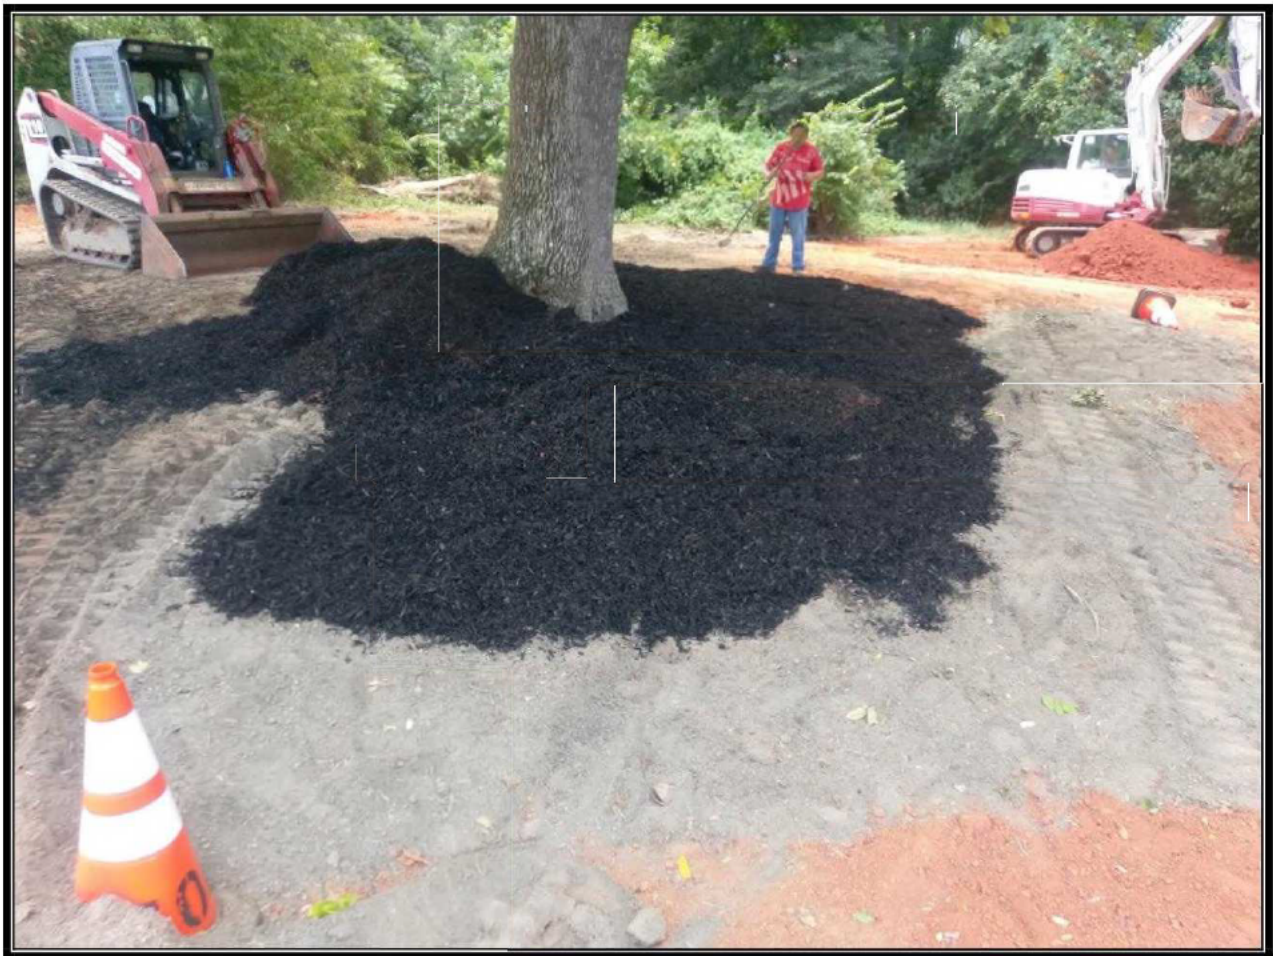
OFFICIAL PHOTOGRAPH NO. 9
U.S. ENVIRONMENTAL PROTECTION AGENCY

Subject: ER installed mulch under the surface scraped tree line area after snow fencing, red "Danger Asbestos" tape around the tree line to identify the depth of removal and the presence of ACM, breathable plastic sheeting, and topsoil were in place.
